Errata
MSP430F5526 Microcontroller

This document describes the known exceptions to the functional specifications (advisories).

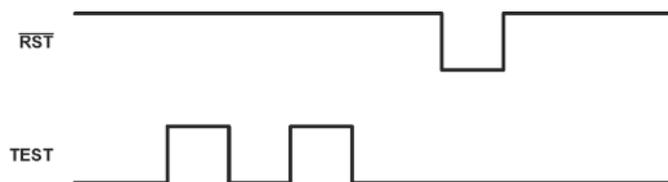
- Toggle the TEST pin twice when nRST is high and after 50us pull nRST low.

Note: This toggling of TEST pins is not subject to timing constraints. The appropriate level transitions on TEST pin, followed by a RST pulse after 50us, are sufficient to trigger an exit from BSL mode.

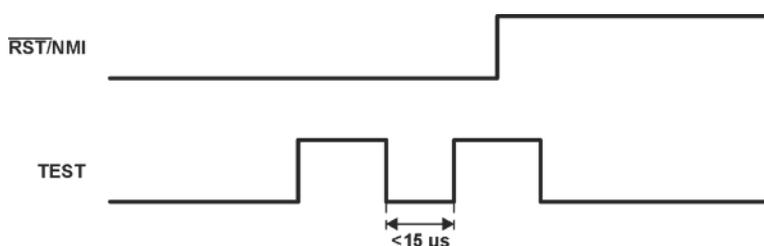
Function BSL entry sequence is subject to specific timing requirements

Description The BSL entry sequence requires that the low phase of the TEST/SBWTCK pin does not exceed 15us. This timing requirement is faster than most PC serial ports can provide, as shown in the following picture. If this requirement is not met, the entry sequence fails and the SYSBSLIND is not set.

Workaround An external hardware solution is recommended to provide the appropriate BSL entry sequence. See [http://processors.wiki.ti.com/index.php/BSL_\(MSP430\)](http://processors.wiki.ti.com/index.php/BSL_(MSP430)) for recommendations on available BSL hardware.
