# **TMS320F28044 Digital Signal Processor Silicon Revision 0**

## **1 Introduction**

This document describes the silicon updates to the functional specifications for the TMS320F28044 digital signal processor (DSP).

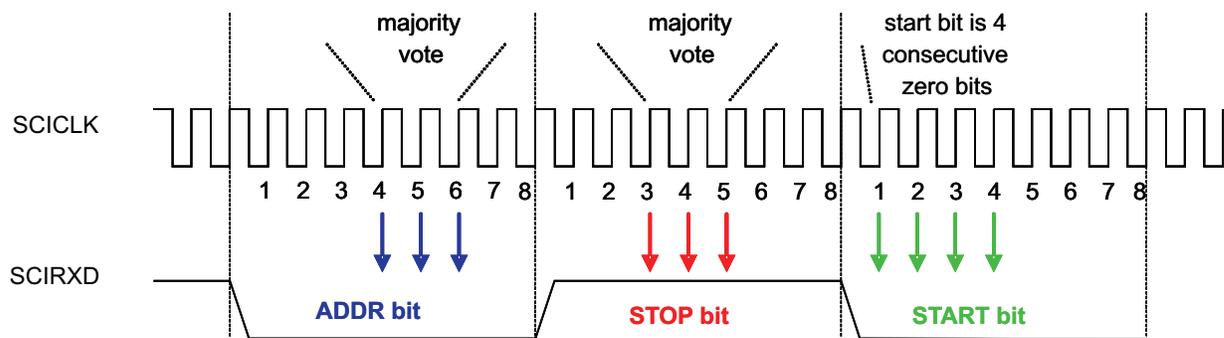
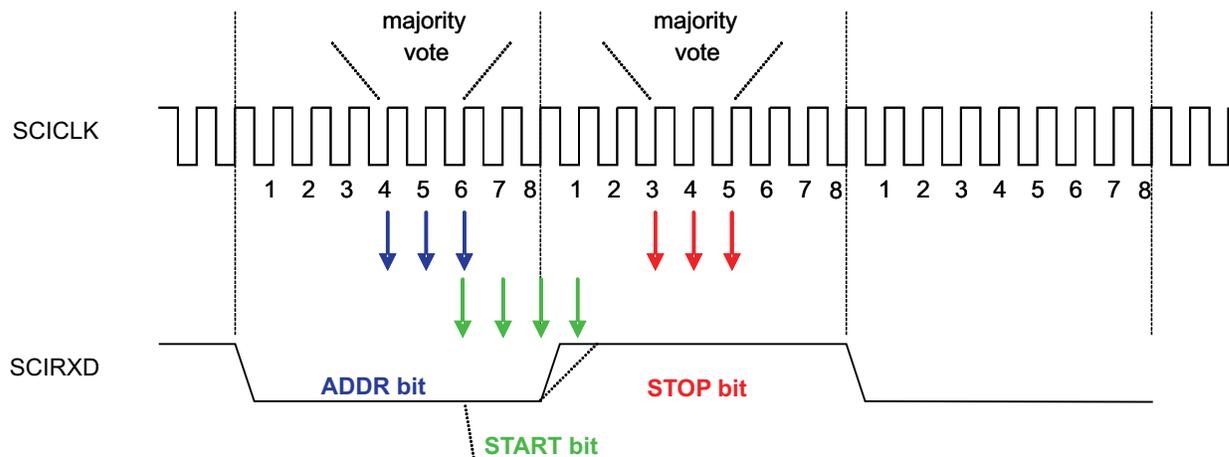
**Figure 3. Difference Between Expected and Erroneous Operation of START Bit**

**Advisory**                      **SCI: Incorrect Operation of SCI in Address Bit Mode**
**Revision(s) Affected**      0

**Details**                      SCI does not look for STOP bit after the ADDR bit. Instead, SCI starts looking for the start bit beginning on sub-sample 6 of the ADDR bit. Slow rise-time from ADDR to STOP bit can cause the false START bit to occur since the 4th sub-sample for the start bit may be sensed low.

**Workaround(s)**                      Program the baud rate of the SCI to be slightly slower than the actual. This will cause the 4th sub-sample of the false START bit to be delayed in time, and therefore occur more towards the middle of the STOP bit (away from the signal transition region). The amount of baud slowing needed depends on the rise-time of the signal in the system. Alternatively, IDLE mode of the SCI module may be used, if applicable.
